**SoCalGas-2**

**Prepared Opening Testimony of Rodger Schwecke (November 22, 2019)**

**I.19-06-016**

### **PREPARED OPENING TESTIMONY OF RODGER SCHWECKE ON BEHALF OF SOUTHERN CALIFORNIA GAS COMPANY (U 904 G)**

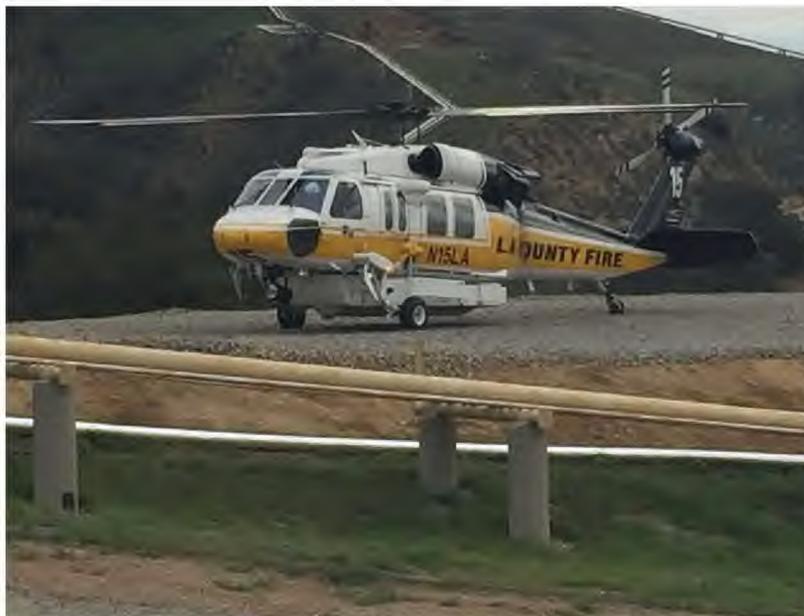
4 In order to promote site safety, SoCalGas established restricted areas, site security and  
5 safety protocols, and evacuation plans. Its efforts entailed deploying appropriate safety and  
6 security personnel on site and in the surrounding community. This included engaging private  
7 security, paramedics, and fire control services. A certified industrial hygienist was engaged to  
8 oversee multiple safety and health representatives to continuously monitor gas at certain  
9 designated areas and periodically check gas levels at other areas near the SS-25 well site.  
10 Security personnel established multiple security checkpoints within the facility and restricted and  
11 controlled access to various points throughout the storage field, including the SS-25 site. As an  
12 extra level of precaution, SoCalGas constructed a helicopter pad to enable rapid emergency  
13 response.

14  
15 *Newly Constructed Helipad*

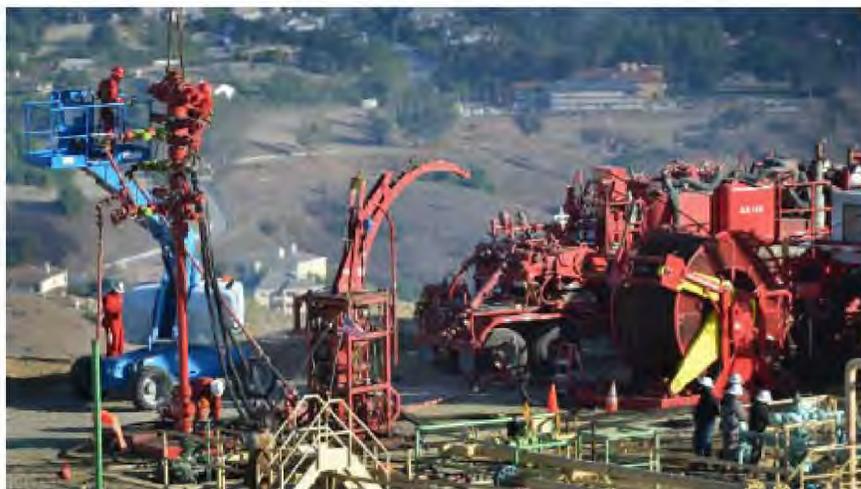
3 Procuring the necessary equipment to clear the hydrate was a logistical and regulatory  
4 challenge. On October 29, 2015, Boots & Coots advised that the best tool for clearing the  
5 hydrate was a specialized piece of heavy machinery known as a coiled tubing unit that has the  
6 capability to snake a flexible tubing tool down the length of tubing. Coiled tubing units typically  
7 operate with internal combustion engines. That was not a viable option at the SS-25 well site  
8 because of ignition risk. Even an electricity-powered coiled tubing unit would need to be  
9 designed in such a way as to eliminate any possibility of ignition, e.g., by insulating electrical  
10 connections. Boots & Coots was able to locate a specialized unit with the necessary  
11 specifications and safety features in Louisiana.

*Coiled Tubing Unit on SS-25 Well Site*

1  
2 The process of procuring the specialized coiled tubing unit to clear the hydrate was time-  
3 consuming but essential. On November 1, 2015 (nine days after the leak was discovered and  
4 seven days after Boots & Coots arrived on site), the specialized coiled tubing unit arrived at  
5 Aliso Canyon. On November 4, 2015, the DOGGR permit to operate the unit was received, and  
6 on November 6, 2015, Boots & Coots used the coiled tubing unit to successfully clear the  
7 hydrate from the SS-25 tubing.

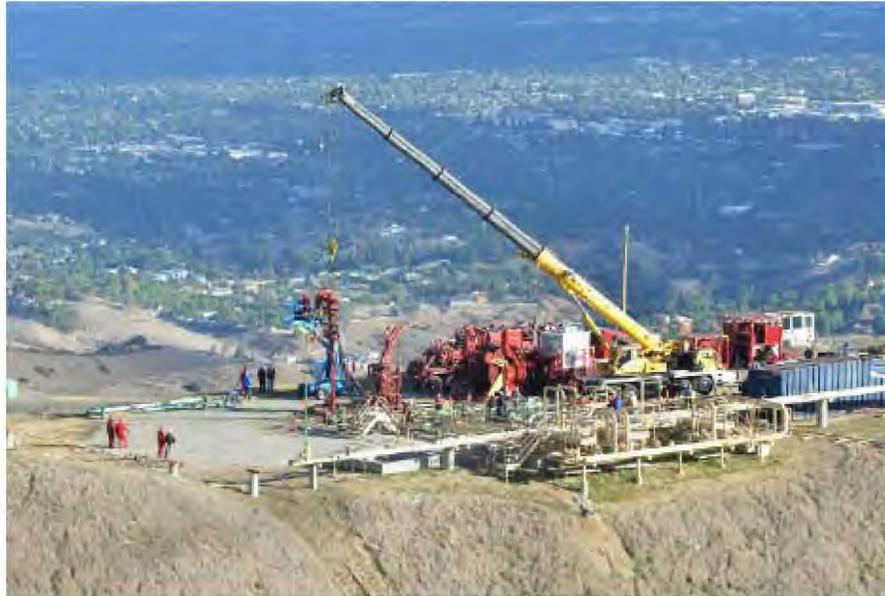
Crane on SS-25 Well Site

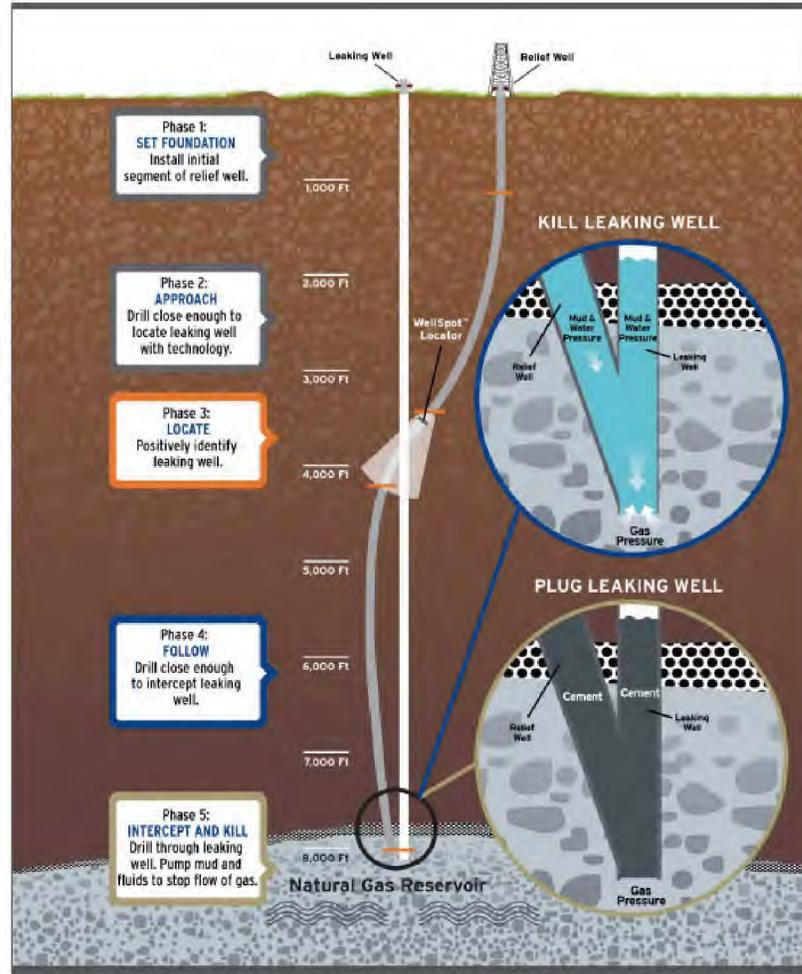
17 Furthermore, it takes time to plan and drill relief wells. A relief well is a complex and  
18 challenging process. Drilling a relief well requires extreme precision, as the drill bit must  
19 intercept the rounded side of the leaking casing on a target area the size of the side of a dinner  
20 plate, more than 8,000 feet below the surface of the earth. Drilling a relief well proceeds in  
21 incremental steps because drilling and identifying the proximity of the drill bit in a three-  
22 dimensional space can occur neither simultaneously nor quickly. Instead, the drilling tool must  
23 be pulled out of the hole so that ranging equipment can be run in its place; then, once the precise  
24 location of the drill bit is known, the ranging equipment is removed, the drill bit is re-inserted,  
25 and it can proceed slightly further; and the process is repeated many times over.

The relief well process is depicted below.

1 On February 10, 2016, Relief Well 1 successfully made a “soft touch” on the SS-25  
2 wellbore at a depth of approximately 8,600 feet underground. The next day, after 69 days of  
3 drilling, performing ranging runs, and analyzing data, Relief Well 1 intercepted and brought the  
4 leak in SS-25 under control by pumping heavy fluids directly into the bottom of SS-25’s  
5 wellbore. At this time, DOGGR declared the well temporarily killed.
